Quassaick Creek Watershed Alliance

Stream @ Road Crossing's Data

Stream Name: Silver Stream Trib. at Port Authorities SPDES discharge

Location description: Stewart Airport off First Street at SPDES Permit 11 discharge

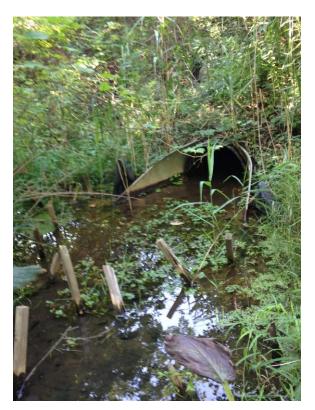
Up Stream conditions: Two out falls at this location. Both had low clear flow. The westerly outfall from a metal culvert had some watercress growing in it, then 20 feet down stream a heavy iron oxide sludge is present. The easterly outfall had a very low flow from a concrete culvert and was clear. No evidence of contamination.

Comments: Iron bacteria colonize the transition zone where de-oxygenated water from an <u>anaerobic</u> environment and produce a sticky slime which is typically rusty in color, but may be yellow, brown, or grey. Groundwater may be naturally de-oxygenated by decaying vegetation in <u>swamps</u>; and useful mineral deposits of <u>bog iron</u> ore have formed where that groundwater has historically emerged to be exposed to atmospheric oxygen. Anthropogenic sources like <u>landfill leachate</u>, <u>septic drain fields</u>, or leakage of light <u>petroleum</u> fuels like <u>gasoline</u> are other possible sources of organic materials allowing soil <u>microbes</u> to de-oxygenate groundwater.

Westerly Outfall /c watercress
